Manhole Inspection Summary

Manhole # S33C__011MH

Insp Date: **1/27/08 9:58 AM**

Location Address: **415 PARK AVE**

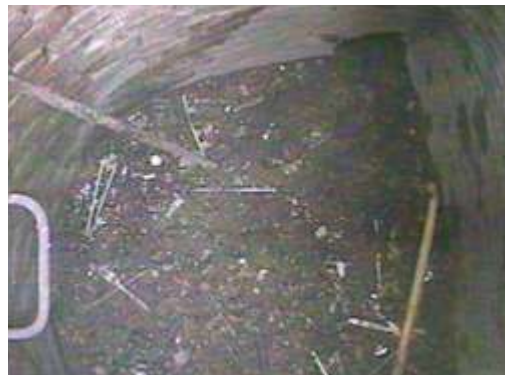
Top View

DEBRIS IN CHANNEL

Deposits: ☐ None ☒ **Mud** ☐ Sludge ☒ **Debris** ☐ Grease

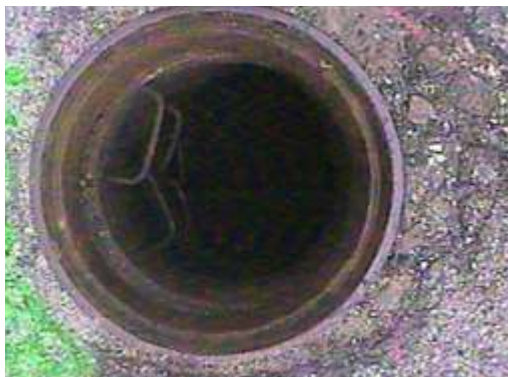
Top View

Frame Offset: **2** (in.) Condition: ☒ Sound ☐ Cracked ☐ Leaks

FRAME OFFSET

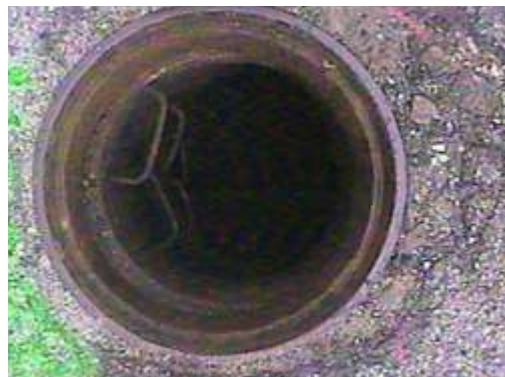
Defect 1

Steps Count: **5** Missing: **0** ☒ **Corroded**

CORRODED STEPS

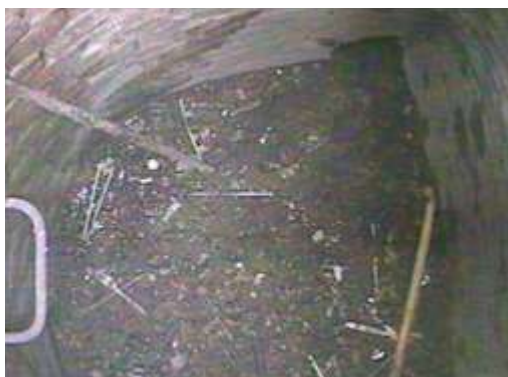
Defect 2

Condition: ☐ Sound ☐ Cracked ☐ Root Intrusion ☒ **Loose Brick** ☐ Deteriorated

Surcharge ☒ **Evidence Of Surcharge** Depth: **1** (ft.) ☐ Active Surcharge Present

loose brick at barrel and evidence
surcharge
